RE: N00014-14-1-0789 Final Report

1. REPORT DATE (DD-MM-YYYY) 28-09-2017			2. REPORT TYPE Final		3. DATES COVERED (From - To) 01-07-2014 - 28-09-2017	
4. TITLE AND SUBTITLE Technology Insertion for Recapitalization of Legacy Systems Program Final Report					5a. CONTRACT NUMBER	
					5b. GRANT NUMBER N00014-14-1-0789	
					5c. PROGRAM ELEMENT NUMBER

Research Program 1:
Effect of Corrosion on Physical Properties
of Highly Stressed Coated Components

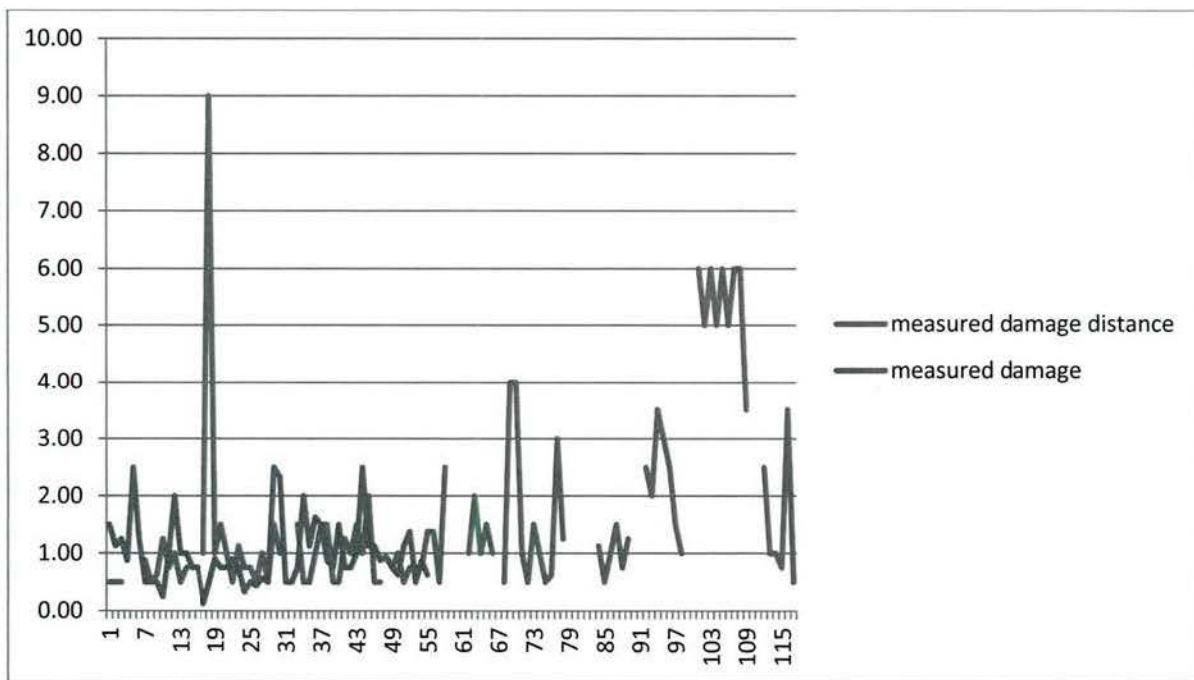
Approximately 55 torsion bars were evaluated inside where the coating was actually removed and corrosion could be evaluated. In Figure 56, the blue line indicates the maximum distance from the splines that the damage occurs. The red line indicates the size of the damage area. For example, the peak around sample 18 indicates that the damage was approximately 9" from the spline end and was less than 1" in diameter. For the bars that were outside (samples 56+), the distance from the end was measured, but the extent of damage couldn't be measured without removing the coatings.

Figure 56 - Measured Damage on Torsion Bars

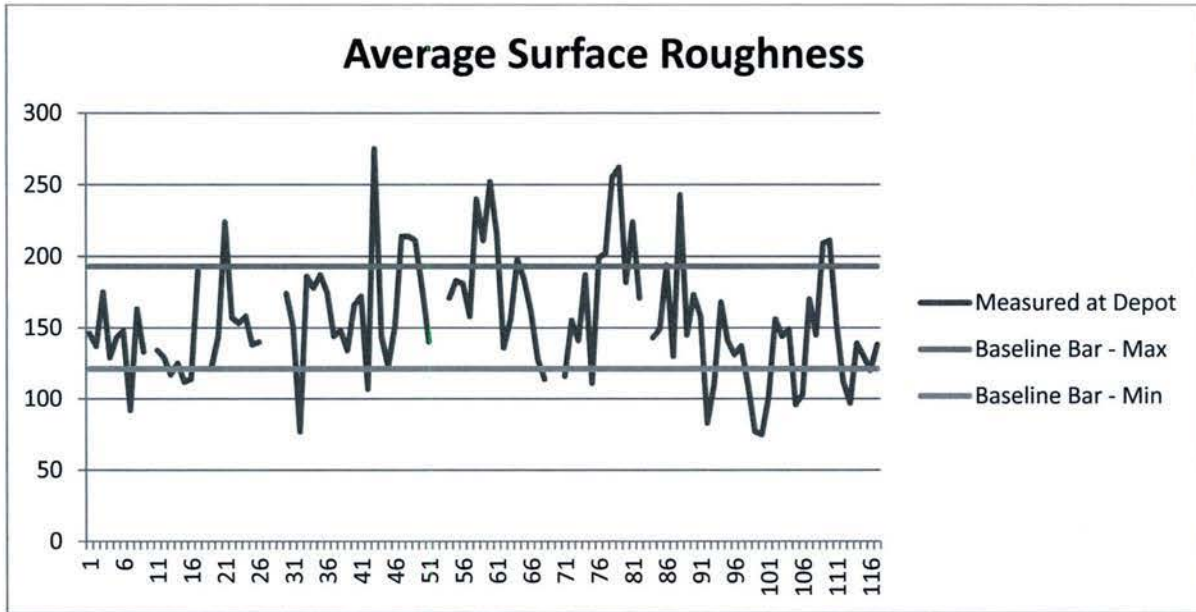
Additionally, for the torsion bars that were inside, every damage location was cleaned and the surface roughness measured. Those roughness measurements are plotted in Figure 57, along with lines of the minimum and maximum roughness for a new torsion bar.

Figure 57 - Average Surface Roughness of Damage Areas

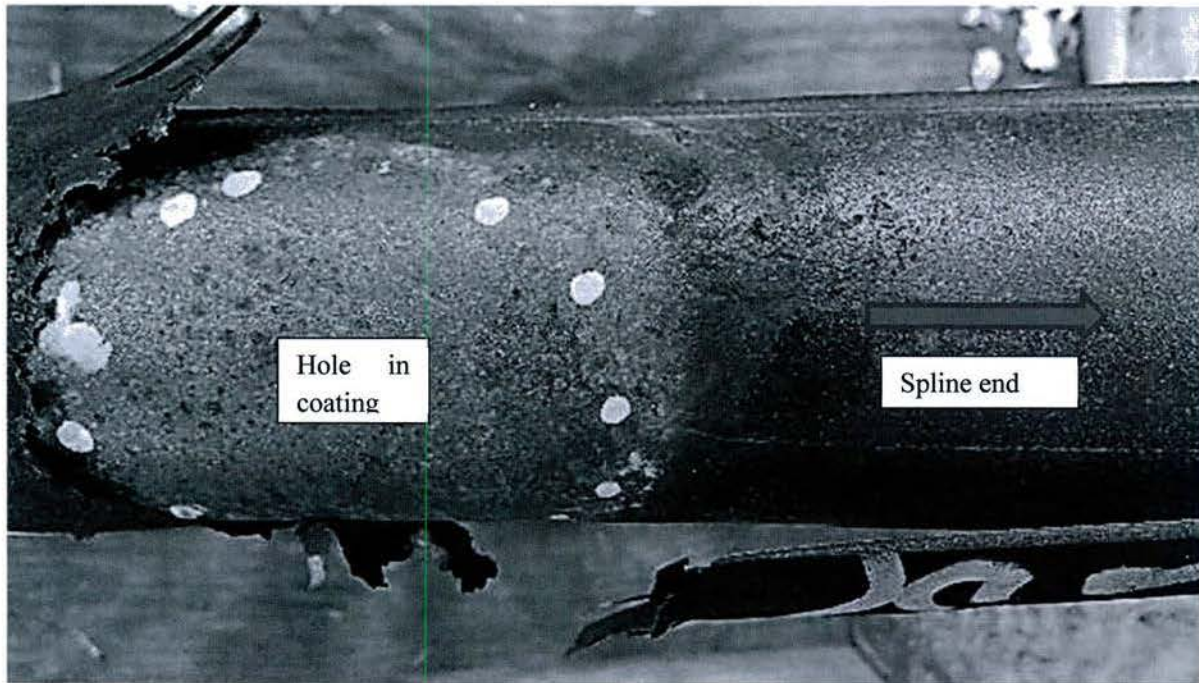
In order to examine the surface the torsion bar around the hole the coating was removed from the torsion bar. The coating on this torsion bar was not bonded very well to the surface of the torsion bar. Once the coating was removed it was found that the entire surface of the torsion bar from the hole to the spline end exhibited corrosion. In addition, the corrosion beneath the poorly bonded coating was greater than the corrosion in the hole (Figure 61)

Figure 61 - Corrosion on Surface of Torsion Bar within Hole and Away from Hole

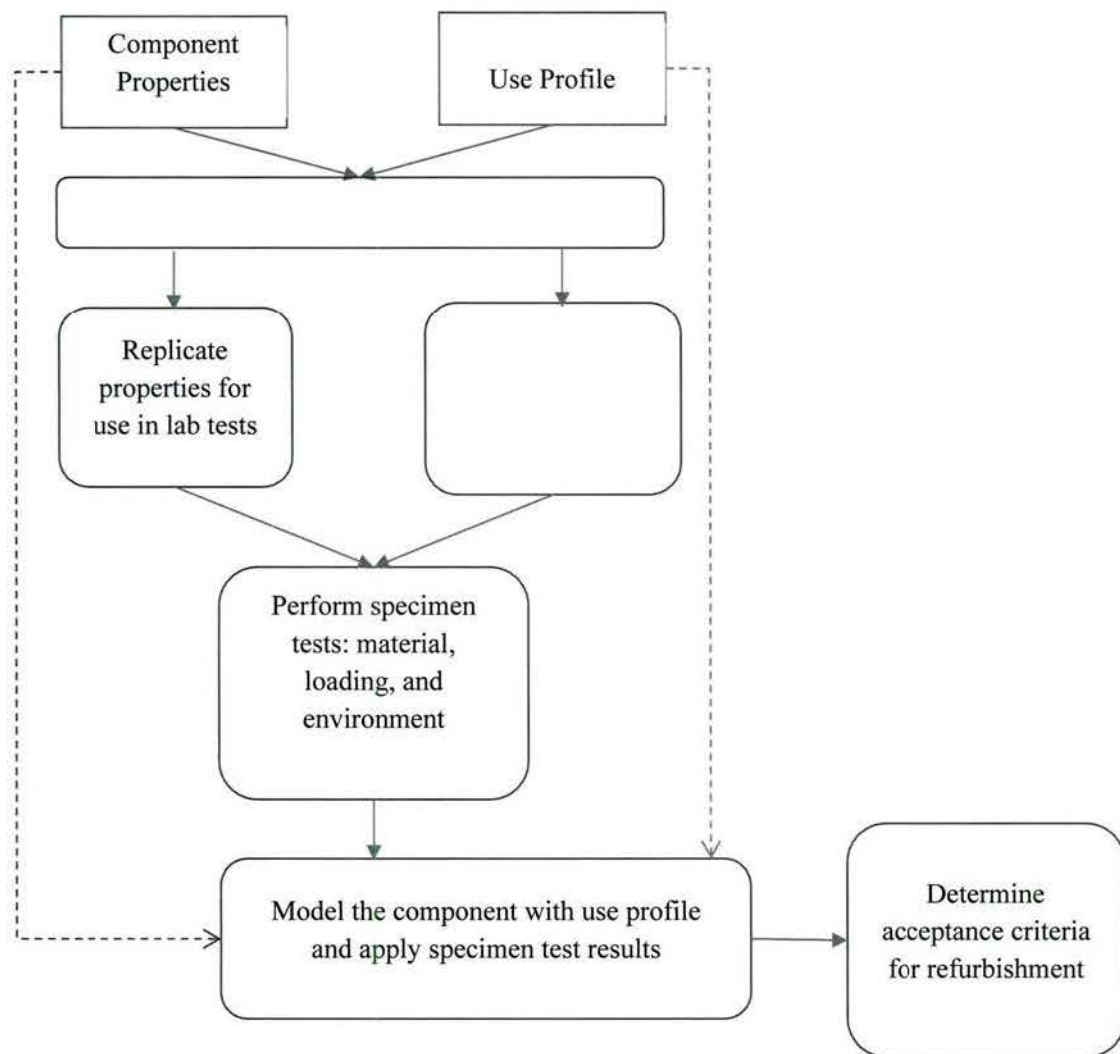
Figure 103- Mechanical Evaluation Process for Recapitalization

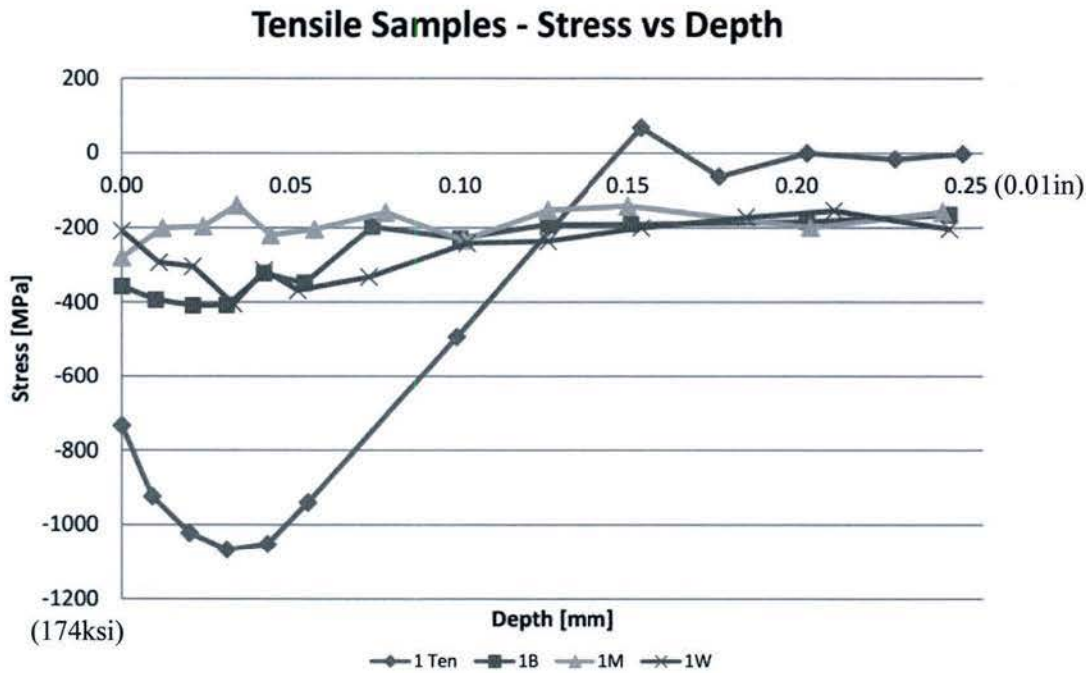
Figure 125 - X-ray diffraction results of tensile samples

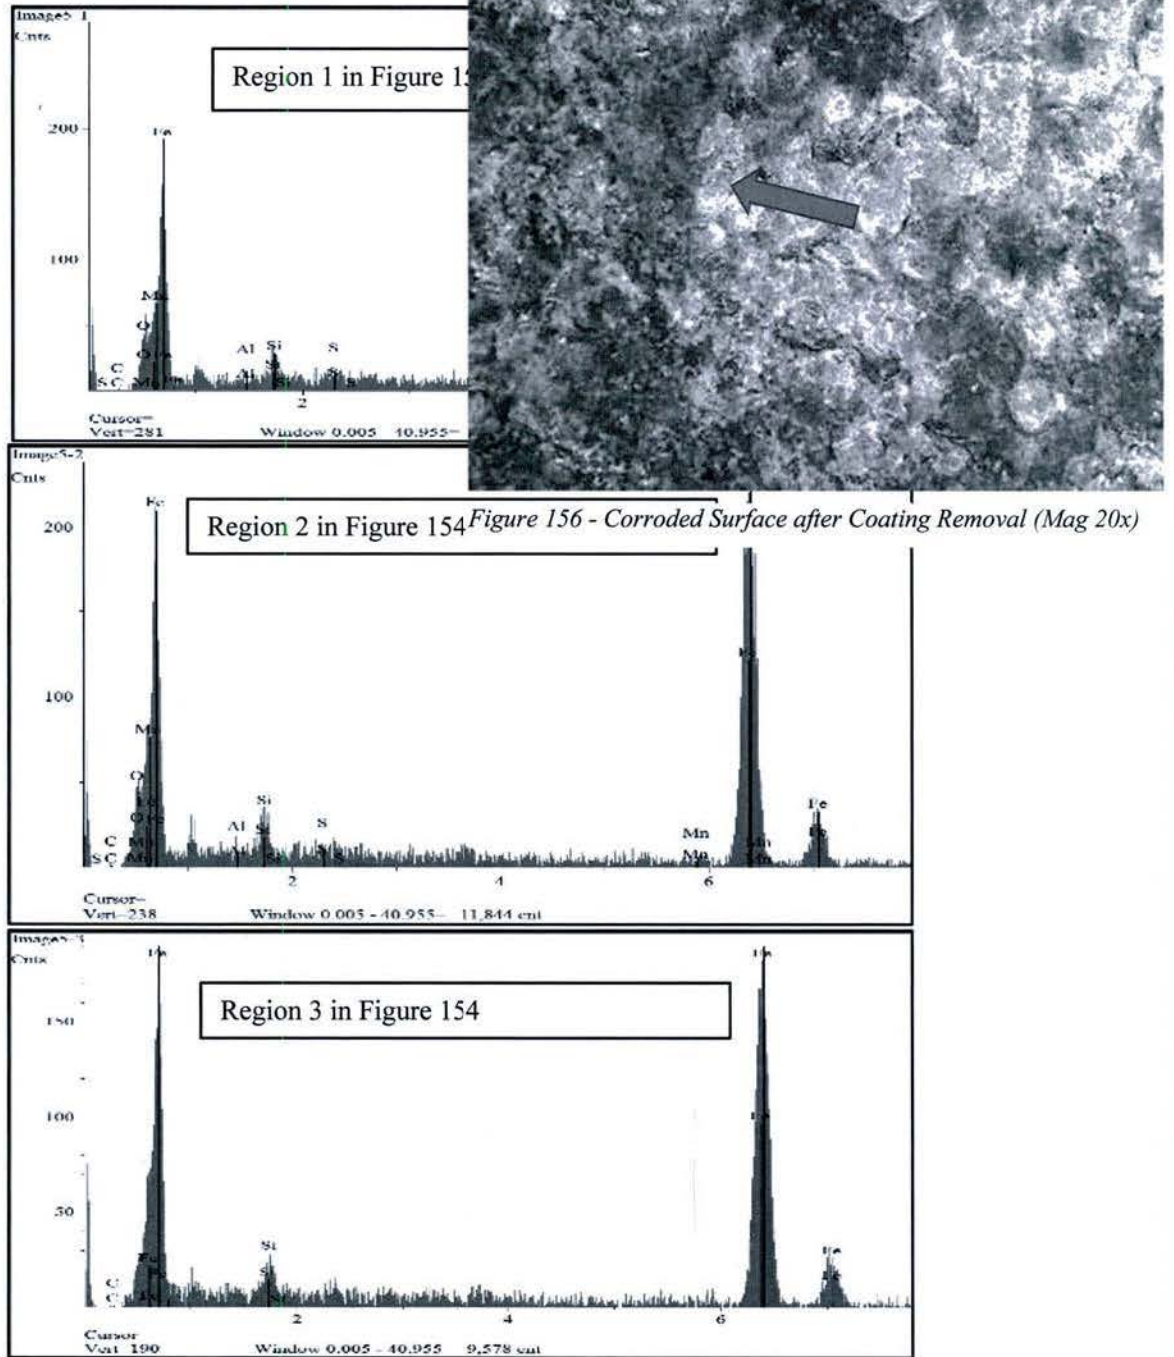
Figure 155 - Non-Dispersive X-ray Analysis from Figure 154

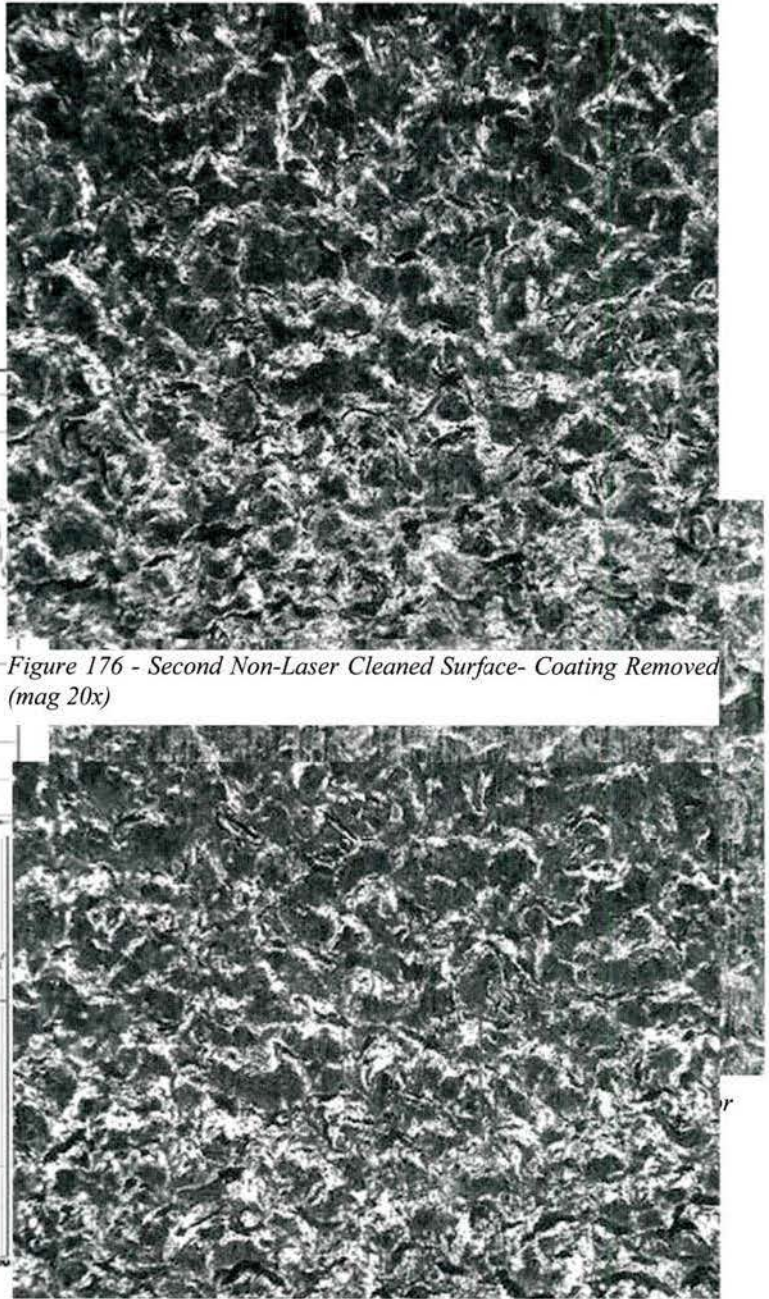
Figure 176 - Second Non-Laser Cleaned Surface- Coating Removed (mag 20x)

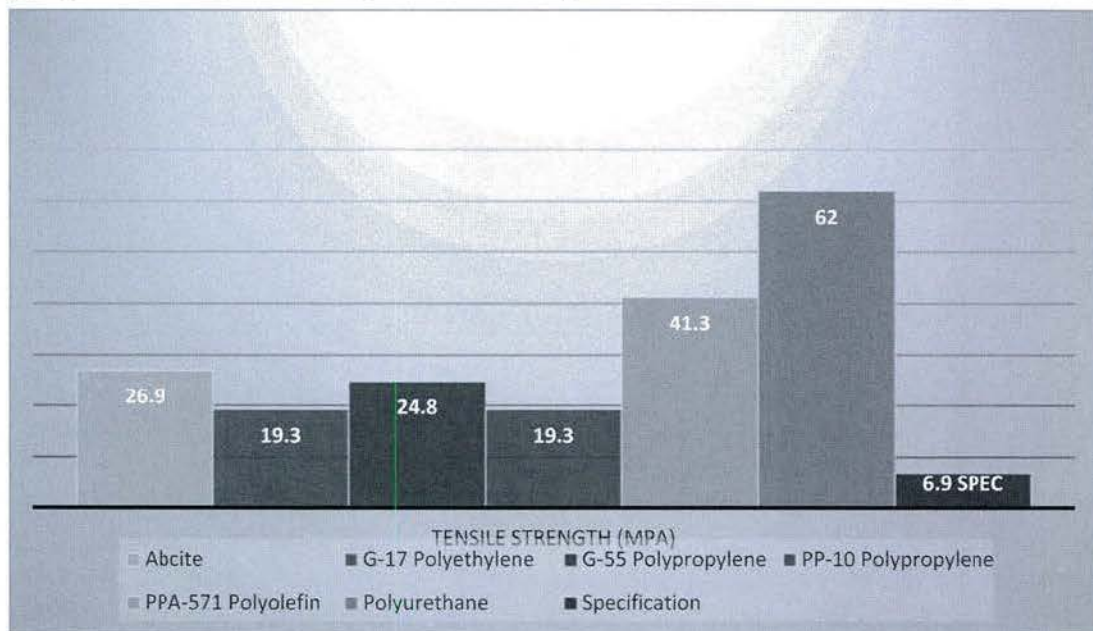
Figure 186 - Ultimate Tensile Strength (MPa)

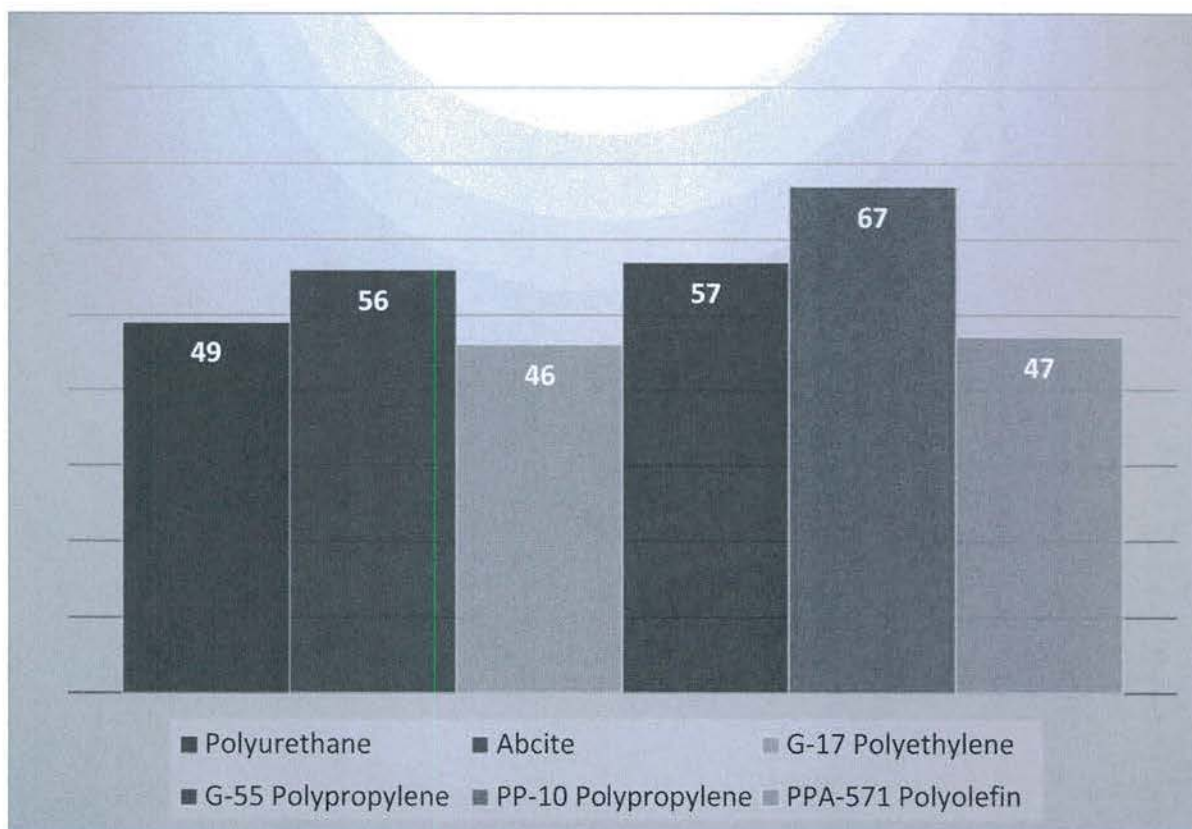
Figure 188 - Shore D Hardness of Candidate Flame Spray Coatings

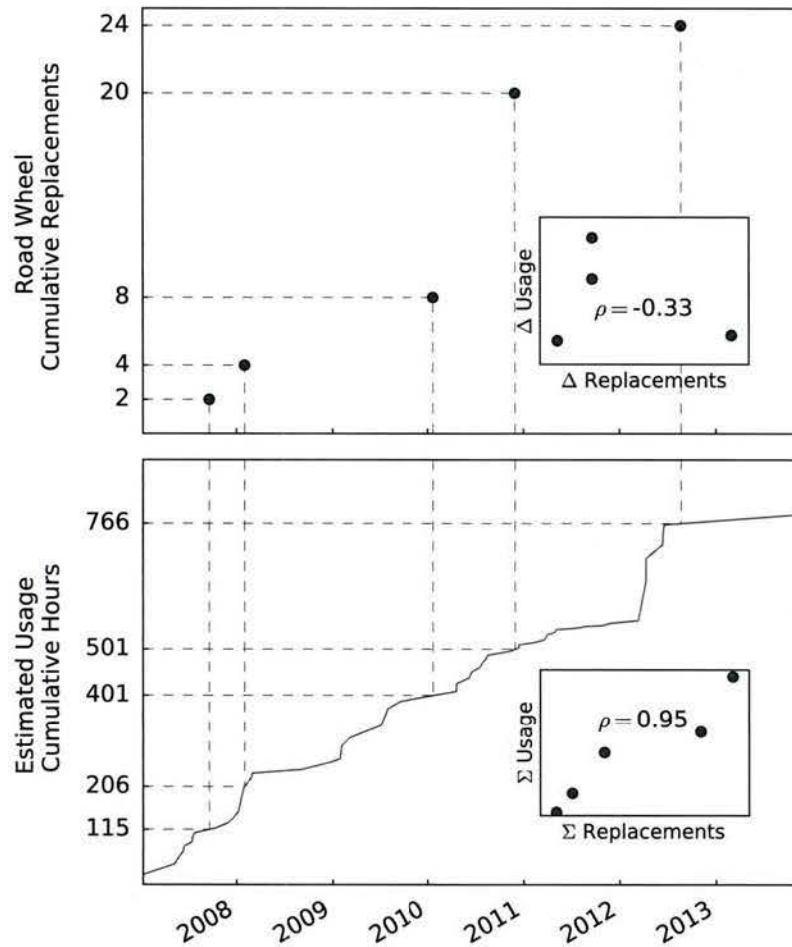
Figure 1.7: Cumulative replacement of road wheels over time and estimated cumulative usage. The two inset plots show the correlation between change in usage and change in replacements (top) and between cumulative usage by cumulative replacements (bottom)

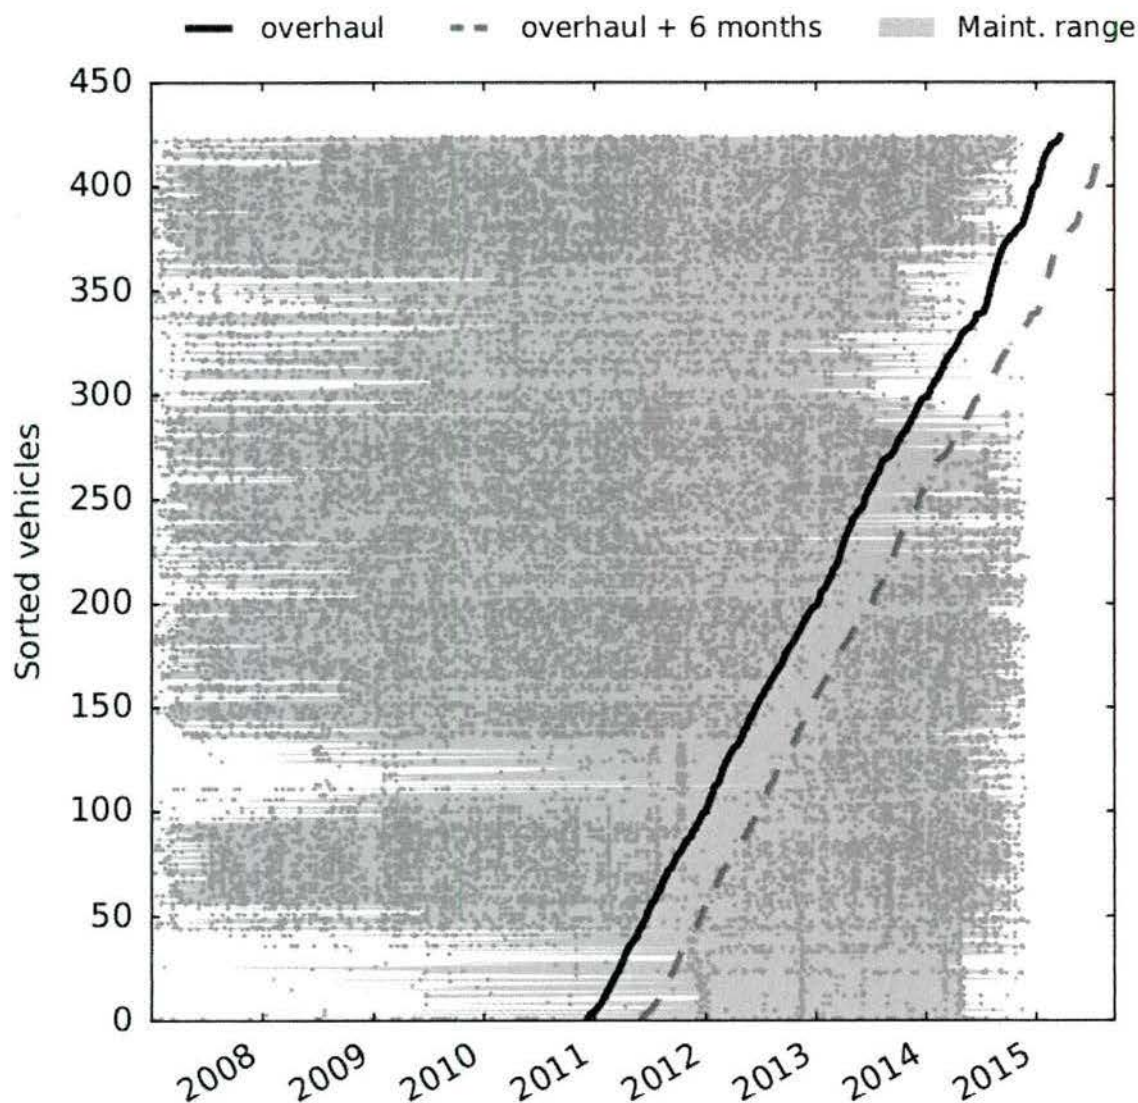
Figure 1.12: Overhaul (dark line) and maintenance events over time for a fleet of vehicles

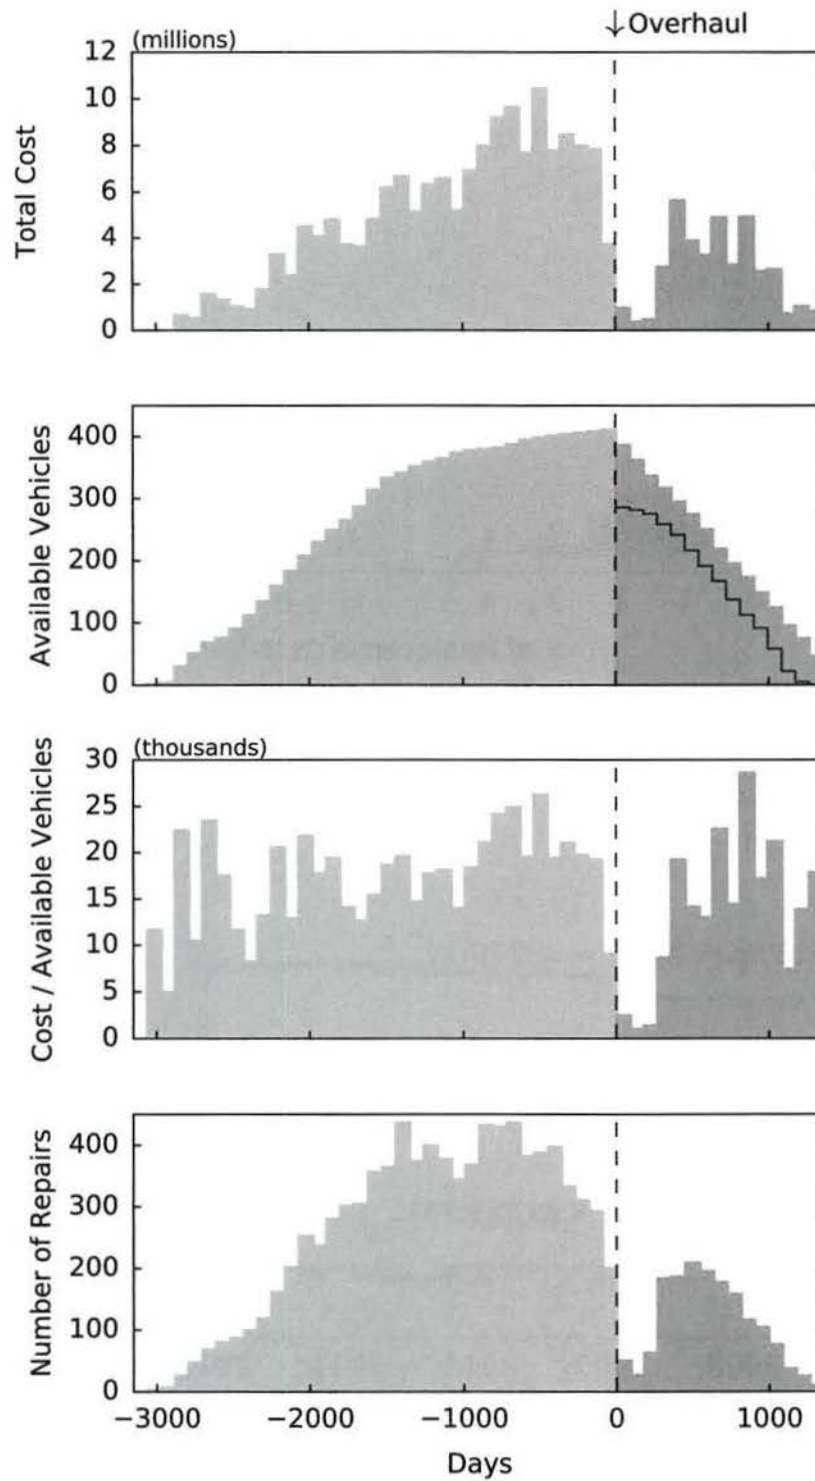
Figure 1.13: Vehicle information including cost, availability, and number of repairs with respect to each vehicles' overhaul date. Before overhaul is gray, and after overhaul is orange

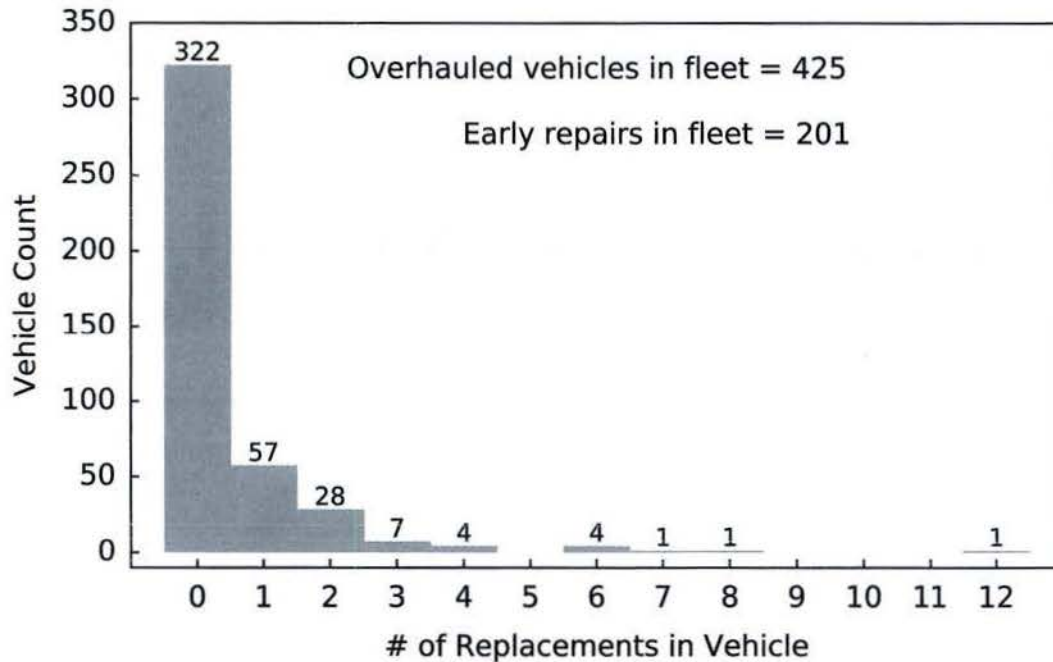
Figure 1.14: Fleet distribution of early repairs, within six months after the overhaul

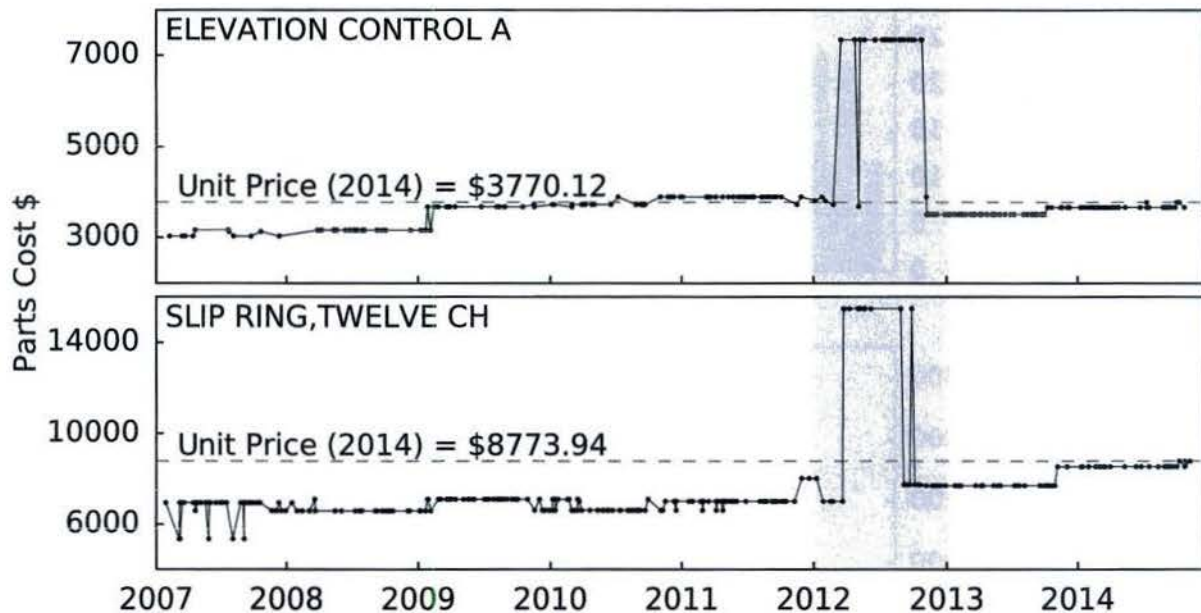
Figure 1.15: Two examples of cost histories for parts that showed anomalous behavior. There was a noticeable spike in price, primarily between 2012 and 2013, for many of the parts

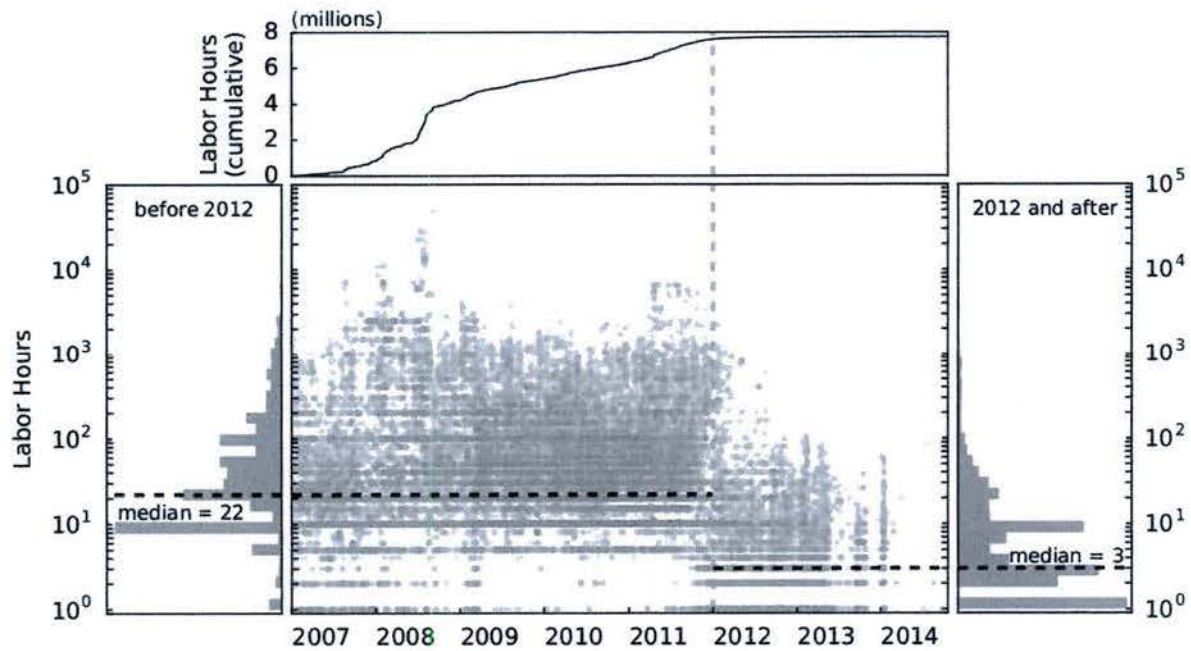
Figure 1.21: Detailed outline of labor hours over time. Labor hours show a shift in behavior after 2012

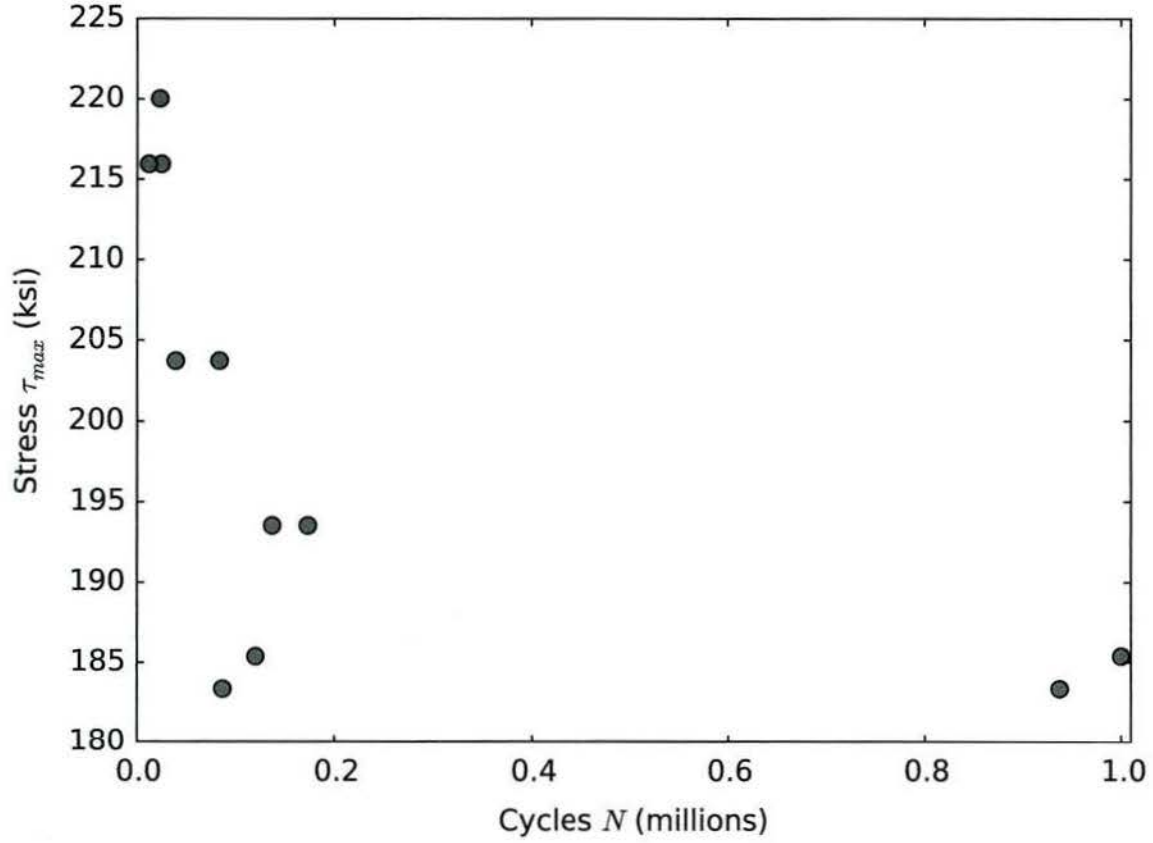
Figure 3.12: Empirically results SN data for uncorroded samples

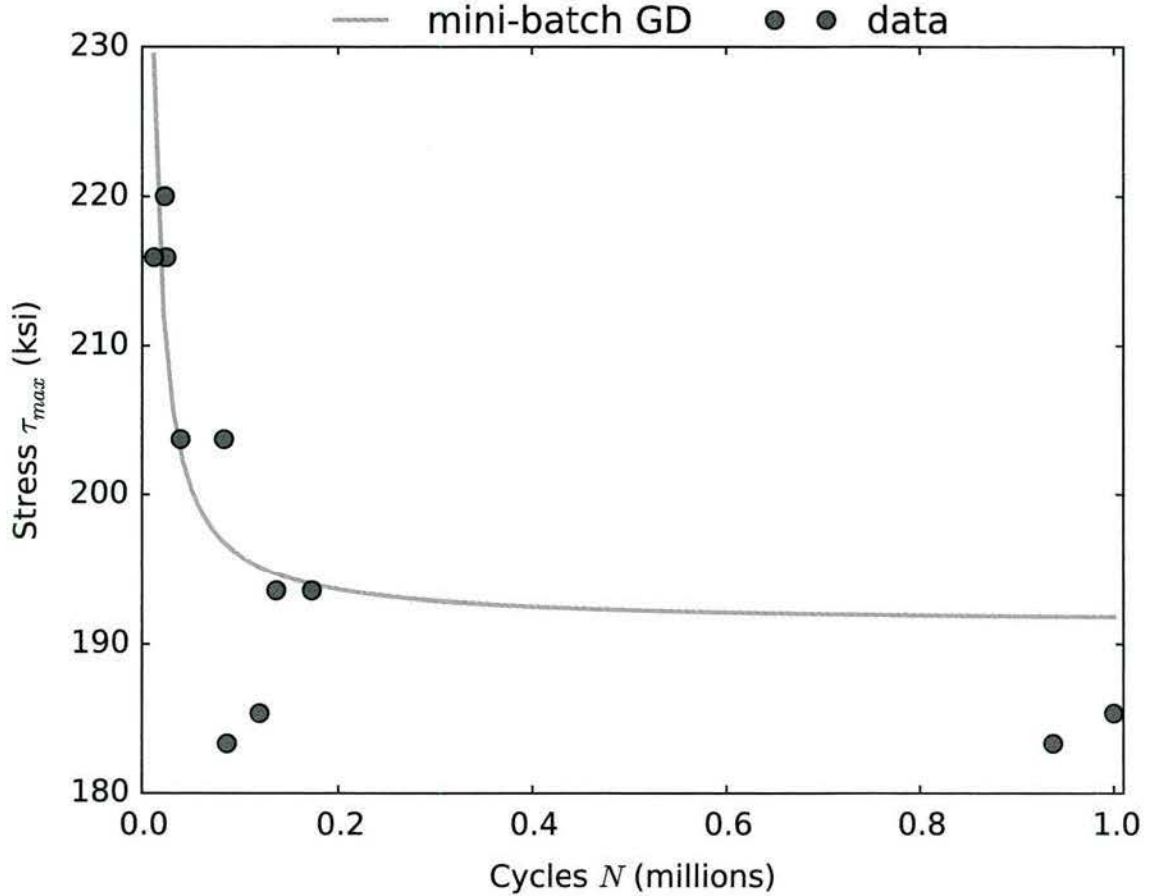
Figure 3.17: The mini-batch gradient decent method used here does not capture the essence of the features we are looking for. The endurance limit is not well interpreted here because data exists below the hyperbola

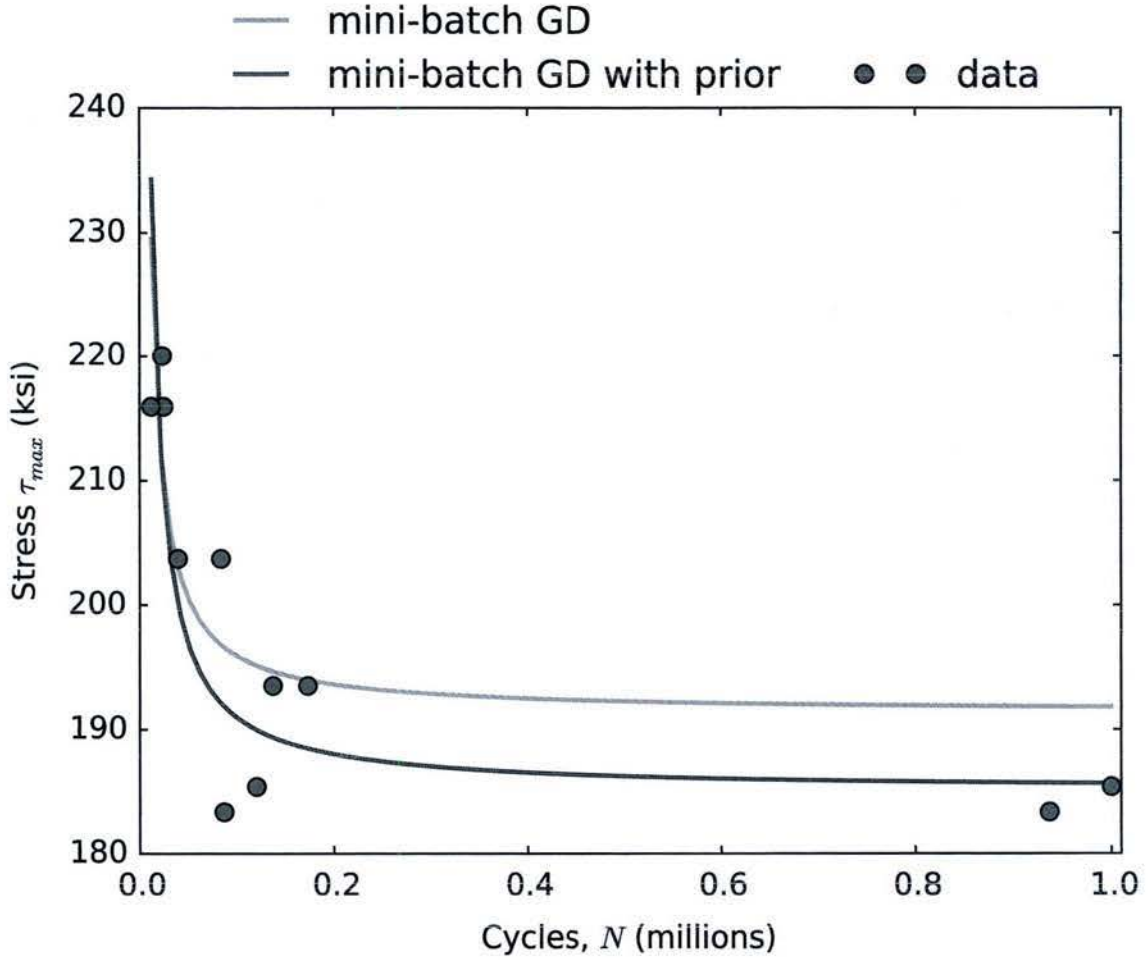
Figure 3.18: The use of prior knowledge encoded in the cost function leads the optimization in a direction more suitable without desired outcome as compared to the previous fit without a conditioned cost function

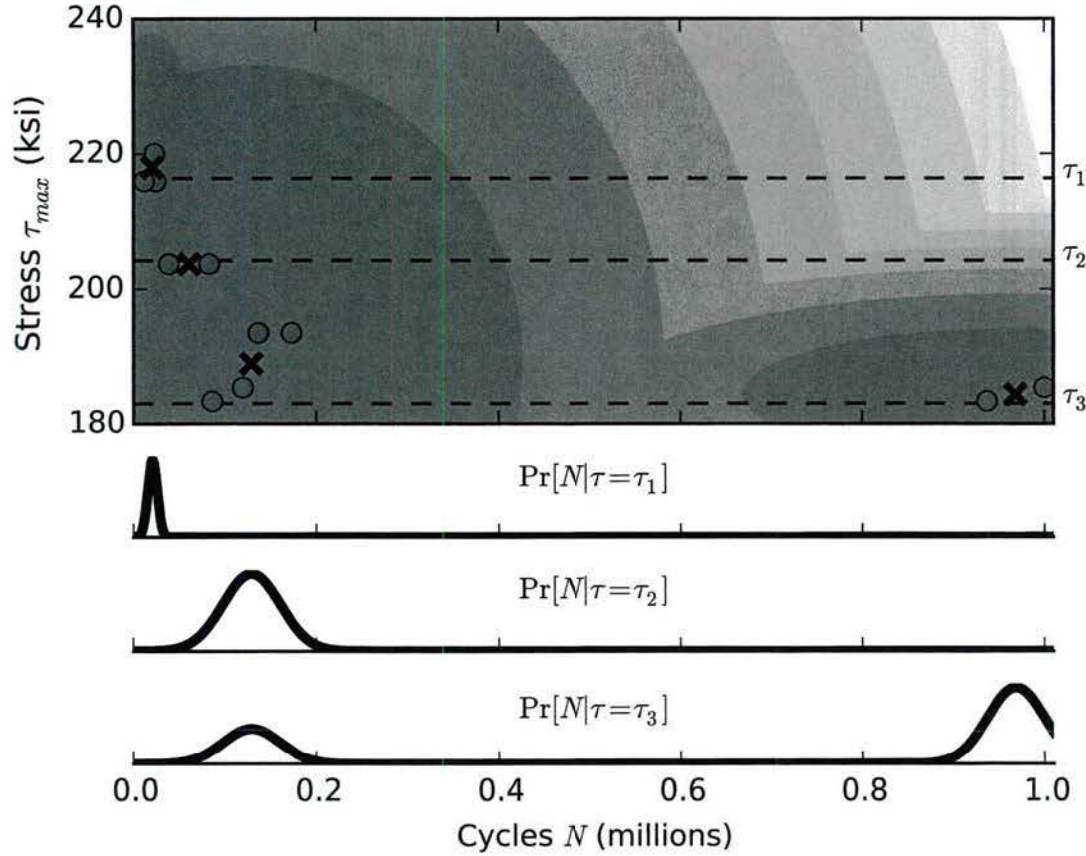
Figure 3.19: Slices of a Gaussian Mixture Model applied to the S-N curve

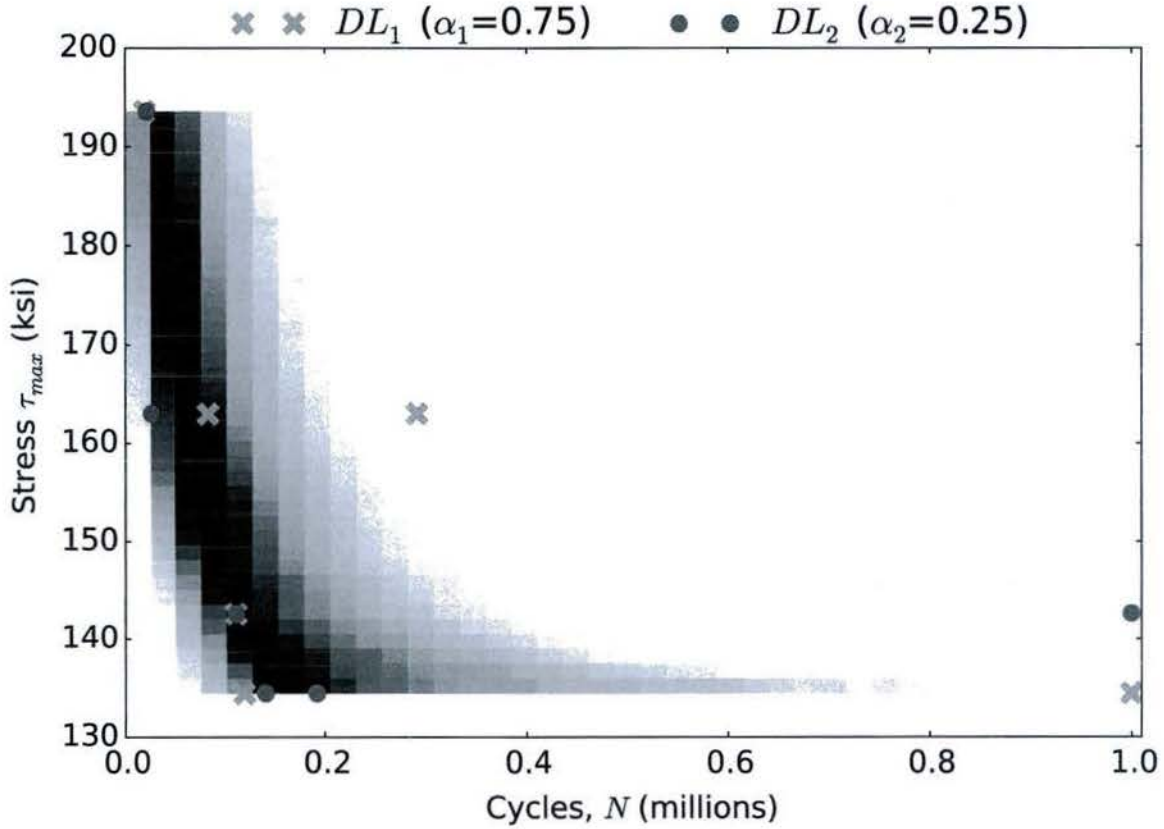
Figure 3.24: Data fusion of two levels of damage DL_1 and DL_2

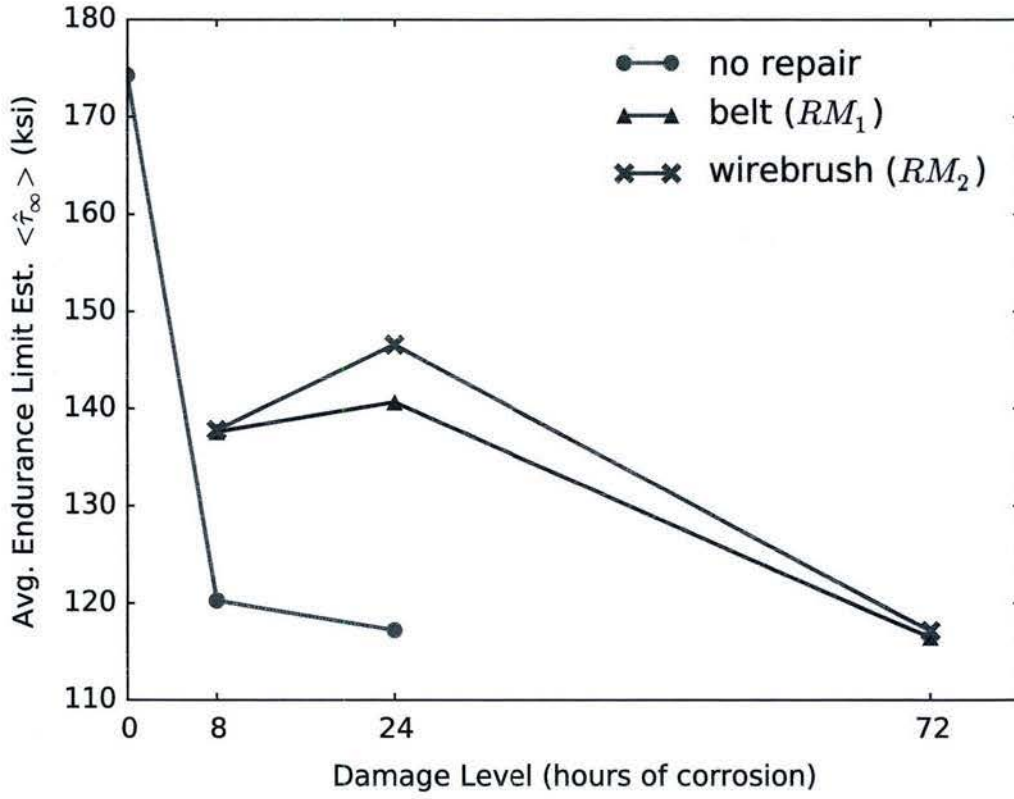
Figure C.10: For the three cases of repair method the model parameter τ_{∞} is plotted at each damage level. Damage level 0 indicates the uncorroded case

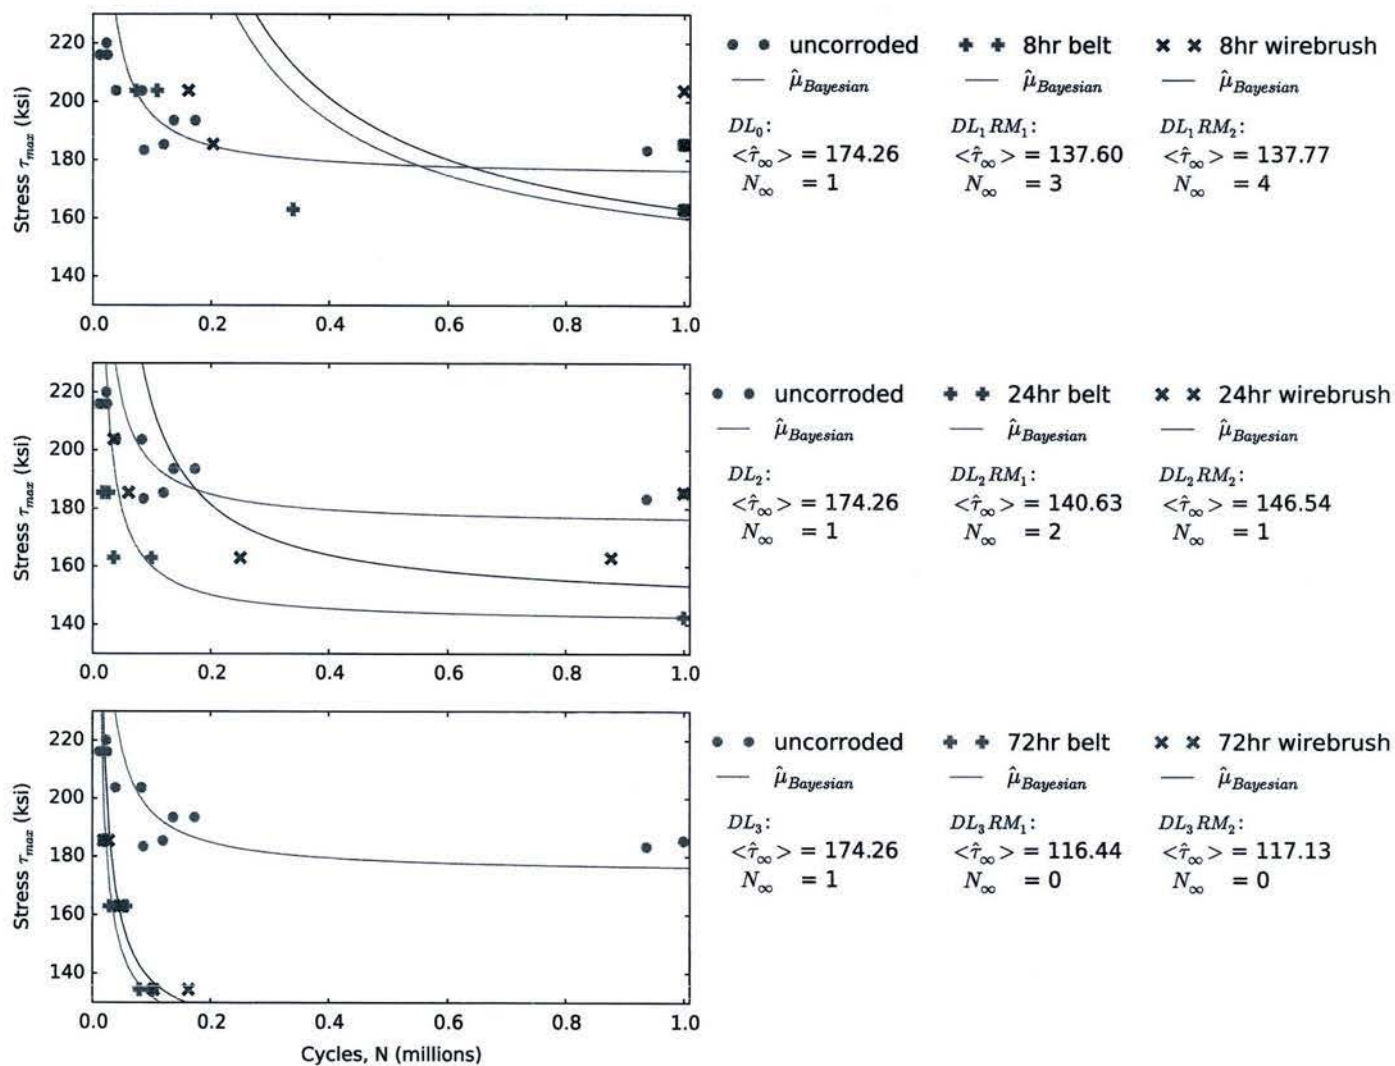
Figure C.11: For each damage level (subplot) the uncorroded case is compared with two repair methods (columns to the right of subplots) by looking at the average endurance limit estimate ($\langle \hat{\tau}_{\infty} \rangle$ ksi) and the number of samples that survived to one million cycles (N_{∞})

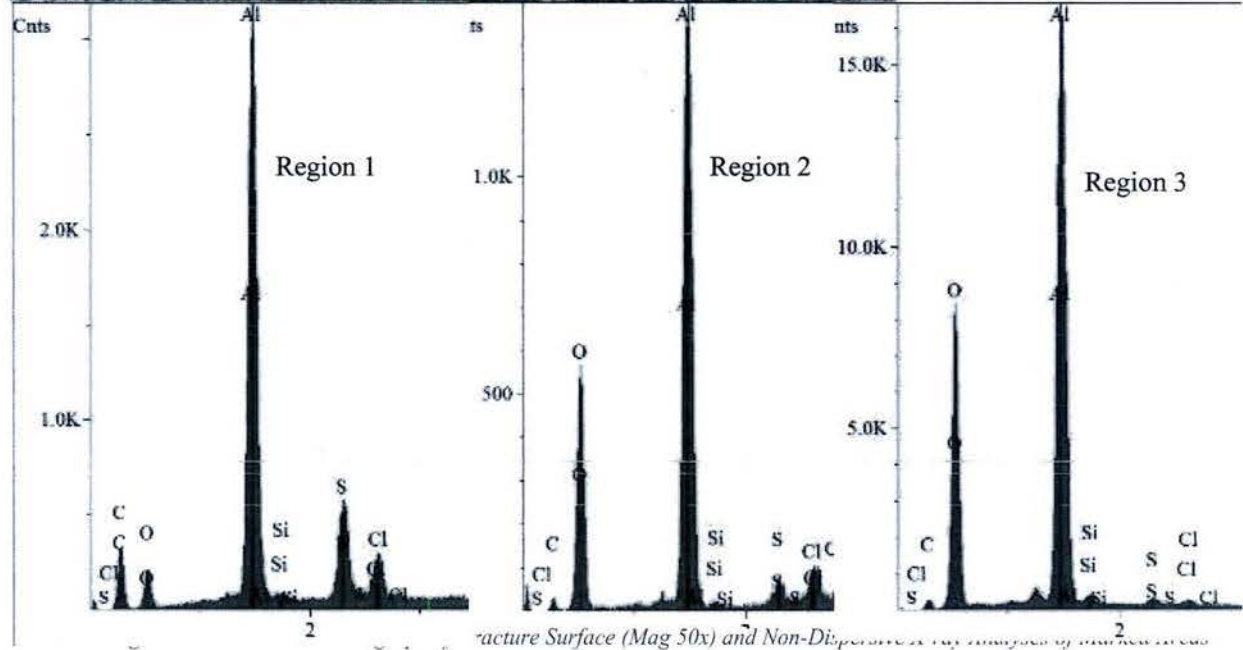
Fracture Surface (Mag 50x) and Non-Dispersive X-ray Composition of Individual Regions
